# Manhole Inspection Summary

Manhole # S29M\_\_048MH

Insp Date: **12/15/08 10:06 AM**

**Location** Address: **773 Carroll St**

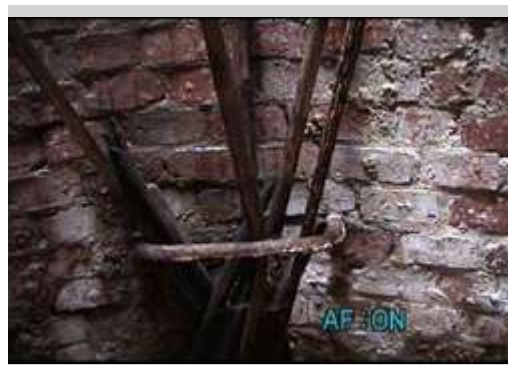
Misc

Count: **6** Missing: **0** ☒ **Corroded**

debris between rungs

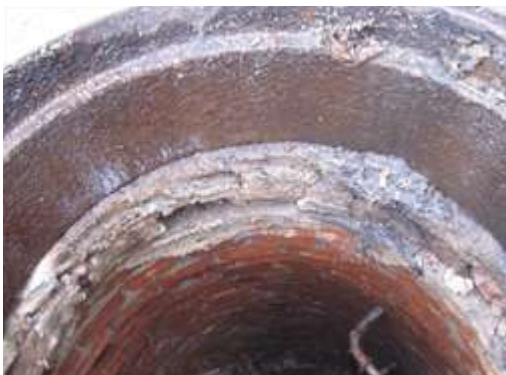
defect 3

Offset: **2** (in.)

offset 2.0

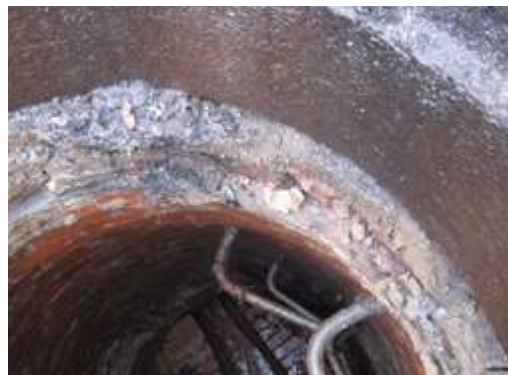
Defect 5

Condition: ☐ Sound ☐ Cracked ☒ **Leaks**

infiltration frame/lid

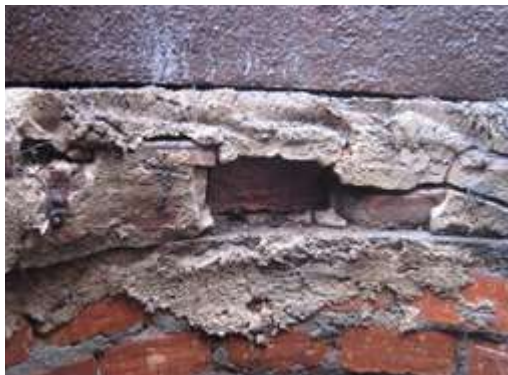
Defect 4

Condition: ☐ Sound ☐ Cracked ☐ Root Intrusion ☐ Loose Brick ☒ **Deteriorated**

Infiltration: ☐ None ☒ **Joint** ☐ Cracks ☒ **Mortar** ☐ Roots ☐ Wall

missing mortar and brick

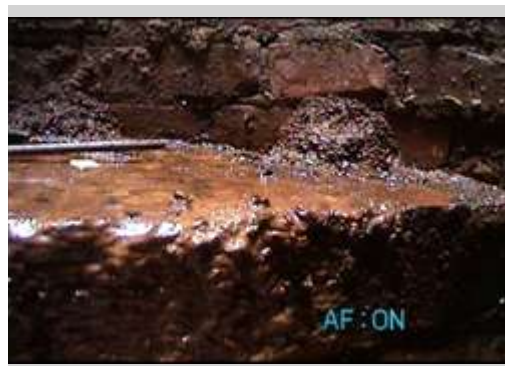
Defect 1

Condition: ☐ Sound ☐ Cracked ☐ Root Intrusion ☐ Deteriorated ☐ Leaks ☒ **Debris**

debris on bench
